This question always arises when the cable lengths cannot be estimated when preparing the offer and planning. But is self-assembly actually more economical in the end? In 2020, Hansford Sensors recommends the use of pre-assembled cable assemblies with defined lengths for 97% of all projects. With this practical example we would like to consider economic aspects and share our long-term experience with you.

## Example:

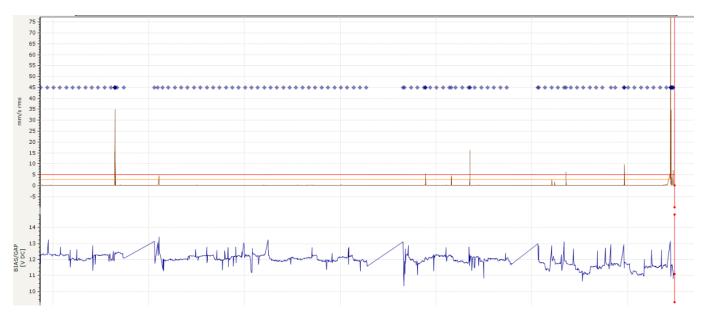
Figure 1

The evaluation of signals one accelerometer on one Drying cylinders in the paper industry showed eyecatching tips in the Vibration velocity signal. The examination of the bias voltage showed abnormalities and an unstable course (Figure 1).

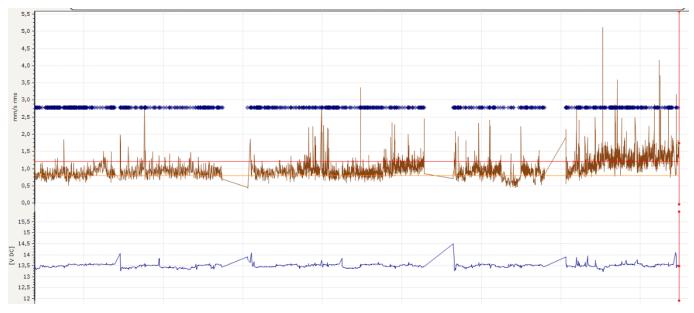
The low-frequency, spectrum shows very increased frequency components that looked very similar to a ski-sloping effect. At this point in time, the plant operator's maintenance department started the first troubleshooting. The effects occurred sporadically and could not be assigned to any external influence. As the number of false alarms increased, the system operator deactivated the affected channels, effectively deactivating a third of his predictive maintenance. In the further course the frequency of the peaks increased, the system operator turned to Hansford Sensors.

Figure 2 shows the same drying cylinder when the support from Hansford Sensors was contacted.

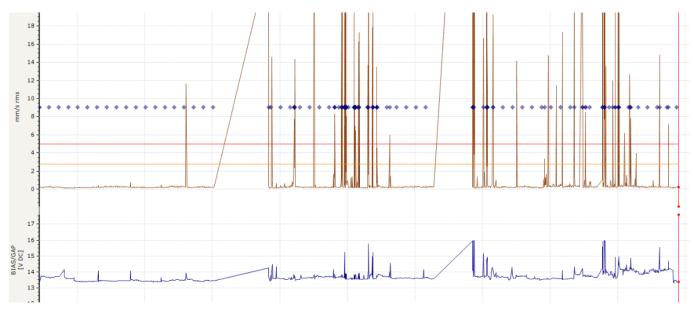
Figure 3 shows the plot of another drying cylinder. In the meantime, the plant operator had deactivated large parts of his system and replaced large numbers of sensors and cables. By replacing the sensor or the cable, the problems were resolved for the time being.

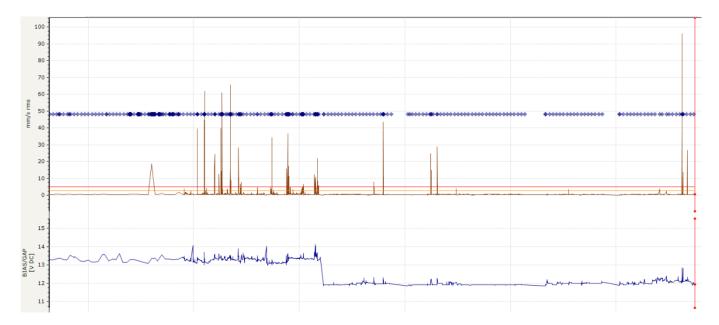
Figure 4 shows measured values up to 65 mm / sec. When the bias voltage drops, the sensor replacement is clearly visible; from this point in time, the measured values immediately fall into typical ranges.

Almost 5 weeks later, the first atypical signals appear again.

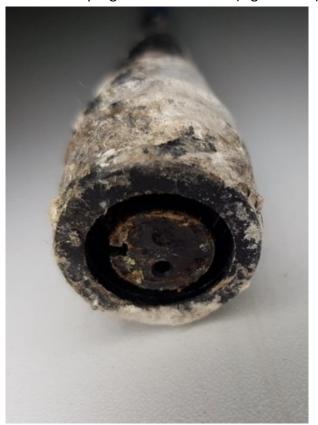
Figure 6

During an on-site inspection and the inspection of the measuring points, it was noticed that the plugs showed corrosion from the inside.

A longitudinal opening of the connector revealed the incorrect processing of the potting material in the connector sleeve. Liquid collected in the cavity. This caused corrosion that ate its way through the connector from the inside. The gradual deterioration in the signal can be traced back to the progressive corrosion. (Figure 5 + 6)

The temporary improvement of the measurement signal when the connector is replaced. The liquid trapped in the cable diffused through the connector and again caused corrosion.

The cables were subsequently exchanged for pre-assembled FEP cable assemblies on the recommendation of Hansford Sensors.

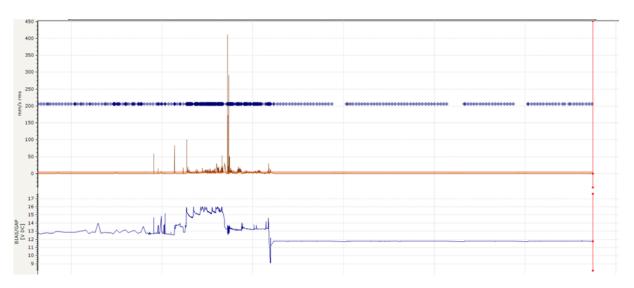
The measured values showed themselves immediately and sustainably in an expected range. Figure 8 shows the trend of an affected dryer cylinder, four months after exchanging it for a cable assembly.
